DELAWARE RIVER BASIN
BRANDYWINE CREEK,
NEW CASTLE COUNTY
DELAWARE

COOL SPRINGS RESERVOIR DAM DE 00014

PHASE 1 INSPECTION REPORT NATIONAL DAM SAFETY PROGRAM

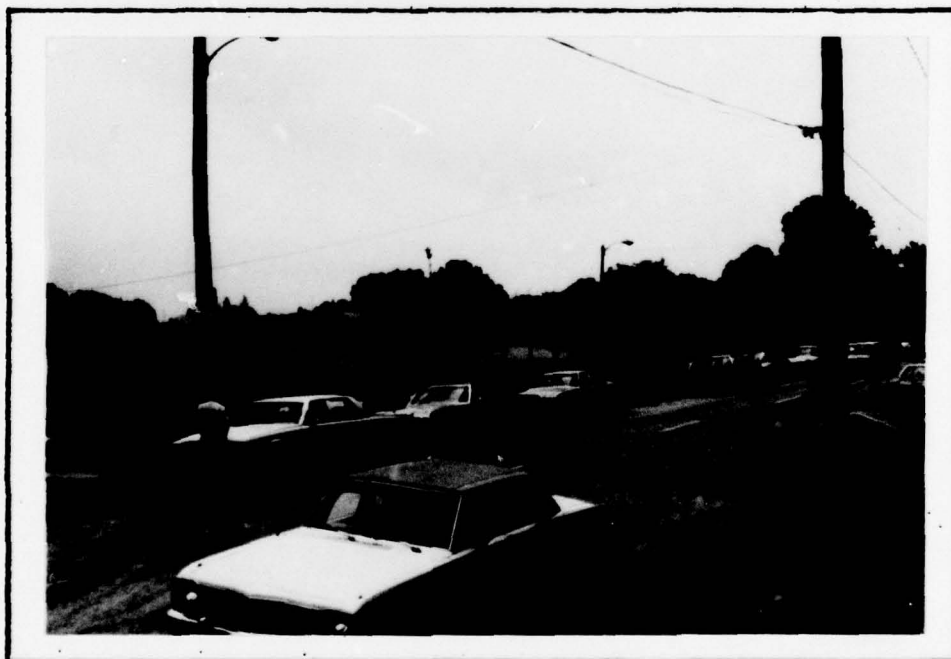
*OVERVIEW OF COOL SPRING RESERVOIR
MAY 1979*

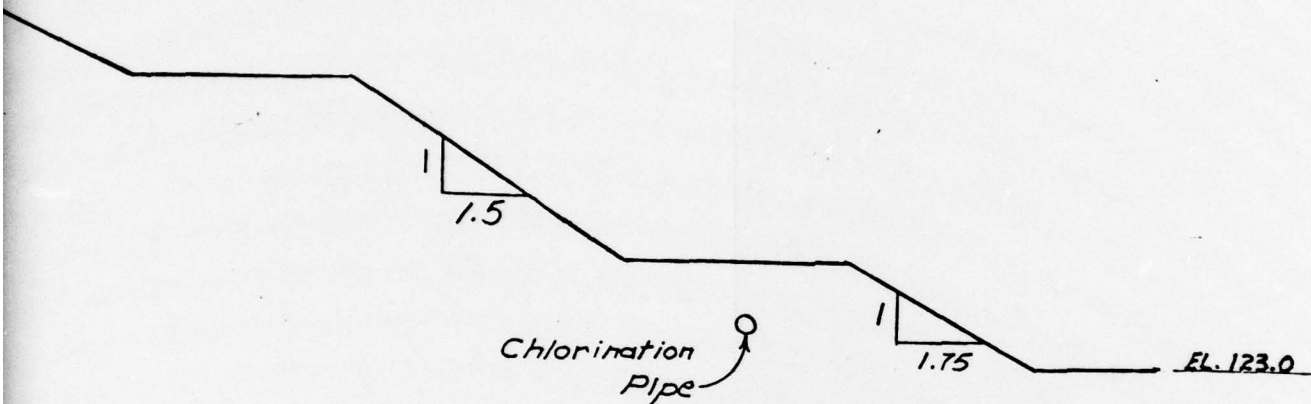
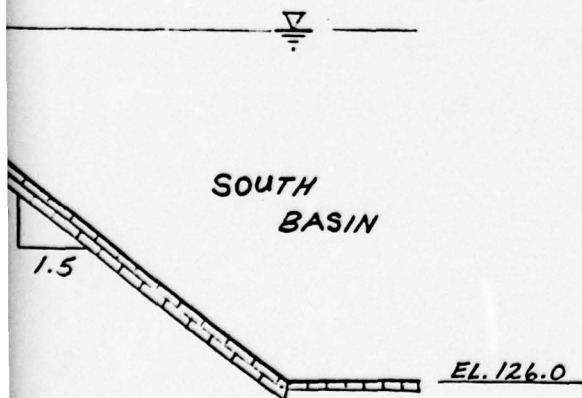
PLATE 3
COOL SPRING RESERVOIR
EMBANKMENT SECTIONS
WILMINGTON, DE
Scale: 1" = 10' May 1979

The dam consists of an earth embankment approximately 1,468 feet long with a maximum height of 23.5 feet. The interior slope is 1.5H:1V and the crest width is 17 feet. The 10th Street embankment slope is 1.5H:1V and is supported by a stone masonry retaining wall as shown on Plate 3, Appendix E. The embankment length along 10th Street is about 288 feet and has a maximum height of about 14 feet at the southeast corner of the reservoir. The exterior embankment slope parallel to Van Buren Street varies from 1.5H:1V to 2.H:1V and is provided with two 12 foot wide berms as shown on Plate 3. This portion of the dam has a length of about 690 feet and has a maximum height of 23.5 feet. The northern exterior slope is 1.5H:1V, has a length of 490 feet and a maximum height of about 18 feet at the northeast corner of the reservoir.

10TH ST. (South) SLOPE

(3) The stone masonry retaining wall supporting the 10th street slope should be repointed and the missing stone blocks replaced to maintain the wall's structural integrity. According to the Owner's representative, this work is presently under way.
